PART C: 1963, 1964 AND 1965 CORVETTE CROSS MEMBER ISOLATION MOUNTS - TSE DATED 11/29/65

**SUBJECT: REAR SUSPENSION CROSSMEMBER
ISOLATION MOUNTS LOOSENING -
1963, 1964 AND 1965 CORVETTES**

BULLETIN NO. TSB #1174

DATE November 29, 1965

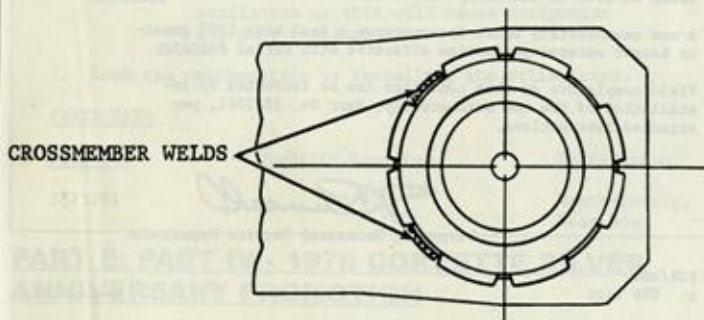
FIGURE 1

Under certain driving conditions on 1963, 1964 and 1965 Corvettes, the rear suspension isolation mounts can pull out of the rear suspension crossmember.

1965 Corvettes built after Serial No. 5116517 have improved mounts with eight retaining tabs rather than four tabs for greater retention.

1. Remove the crossmember, then remove the old mount and clean the mount cavity in the crossmember.
2. Coat the new mount and cavity with chassis grease and with tabs positioned to straddle the crossmember welds, Figure 1, press the new mount into the crossmember applying force to the outer sleeve.
3. Bend all retaining tabs over tightly against the crossmember.
4. Reinstall the rear crossmember. The crossmember-to-frame bolts should be torqued to 55-65 ft. lbs. The torque specification of 20-30 ft. lbs. in the 1964 and 1965 Corvette Shop Manual Supplement and the 1966 Chassis Service Manual is incorrect and should be crossed out.
