# WCFB SOS

I need your help with my WCFB's (2631S & 2614S) please. Ever since Eric Gutscher took me for my first a ride in his brothers 270 hp Corvette back in 1962, I have had a "love hate" relationship with Mr. Will Carter's Four Barrel (WCFB). I restored my 1961, 2 x 4, 270 HP, Corvette and everything is running great. The one exception is the unpredictable 'puddling' of gas at low spots on the intake manifold.

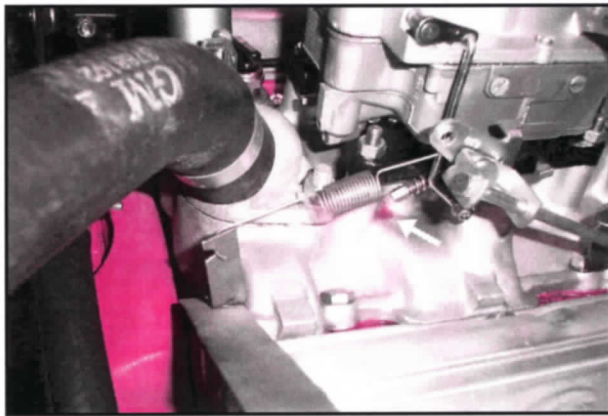
1. A small puddle of gas collects at various low points on the intake manifold. It is usually found around the front of the front carb but on occasion has also appeared around the rear carb and is not consistent (see photo with arrow).
2. The puddles appear primarily during cool down. Again they are not consistent.
