**Fuel Pump 101: Rebuilding an NOS Pump** *Brian McIntyre #25387*

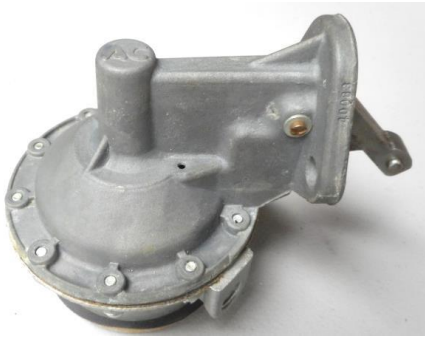
With this knowledge in hand, I set off to secure an AC 40083 fuel pump which would meet the guidelines in the 6th edition of the *NCRS Technical Importation Manual and Judging Guide* (p.135). For the purpose of this discussion, I will paraphrase the description: The top section has a dark gray appearance with the **AC** logo embossed onto the top center and two gussets where the cylindrical portion joins the main body. (Figure 1)

Note the configuration of the upper casting where the pivot pin passes through the casting. The reinforcement is stepped with the first step coming almost up to the bottom of the pivot pin. Also note the vent hole. There is a second vent hole on the other side of the tower.

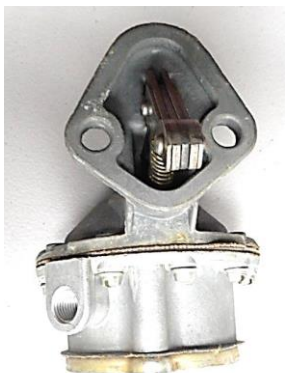
40083 is stamped into the flange that bolts to the block

The pump is constructed of three pieces. The upper and center section are joined by a series of cadmium dichromate slotted Fillister head screws around the perimeter of the pump. The center section has two half-round ears on opposite sides. The full height of the body and the outlets are 180 degrees apart.

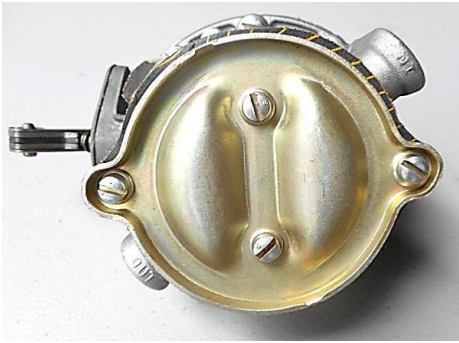
A *second version* of the 40083 pump employs a stamped steel bottom plated in cadmium dichromate and secured with four cadmium dichromate slotted Fillister head screws with a tiny S head mark. The two versions may have been installed concurrently through 1965 with the latter version continuing into 1966 production.

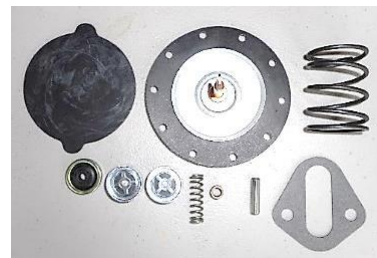
Once the new pump was in hand, I decided to rebuild it since the rubber diaphragm was at least 52 years old and we now have ethanol in our gas. The rebuild kit, Figure 5, replaces the upper and lower diaphragms, springs, seal, pivot pin and check valves.

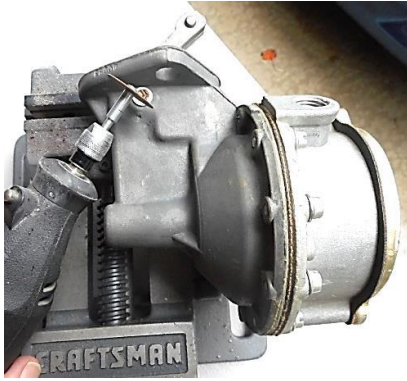
Disassembly required removal of the pivot pin which was crimped. I cut the crimp away with a Dremel tool and drove it out of the casting with a punch.

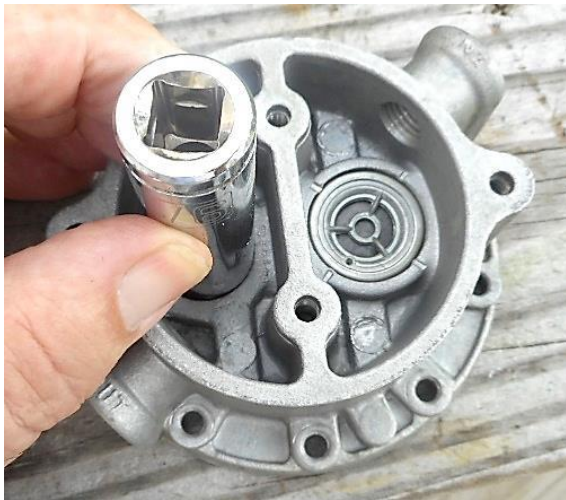
In the center section, there are two check valves for the inlet and outlet of the pump chamber.

Using an appropriately-sized socket, which avoided damaging the check valve, and a hammer, these check valves were tapped out of the casting from one side and the new ones tapped back in from the other side.

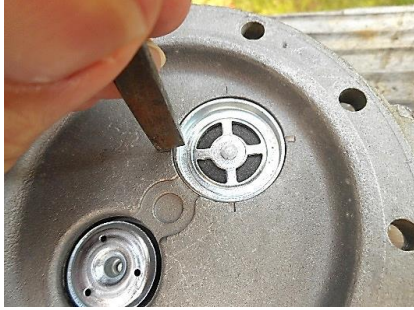
The check valves were then staked with a chisel (Figure A). Installation of the new pump diaphragm on to the pivot arm was a challenge. The general arrangement is shown in Figure B.

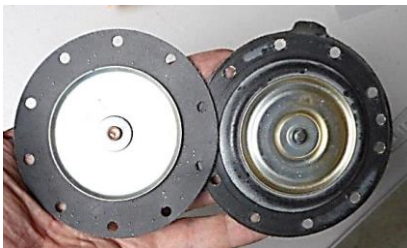
I noted two subtle differences in the rebuild kit and the original. The first was the finish of the lower diaphragm. The original had yellow lines on one side while the replacement was solid black. I only note this because the yellow stripes were visible from the underside of the pump. I have no idea if this is typical of factory production.

The second difference was the presence of a tab on the upper diaphragm. (*right side at the 12 o'clock position*). This tab is readily visible from the top of the engine compartment. A very astute judge might comment on either of these differences.
