Last Tech Article for the year. 2013

Distinguishing Between Original and Reproduction D-305 Distributor Caps

by Bob Baird

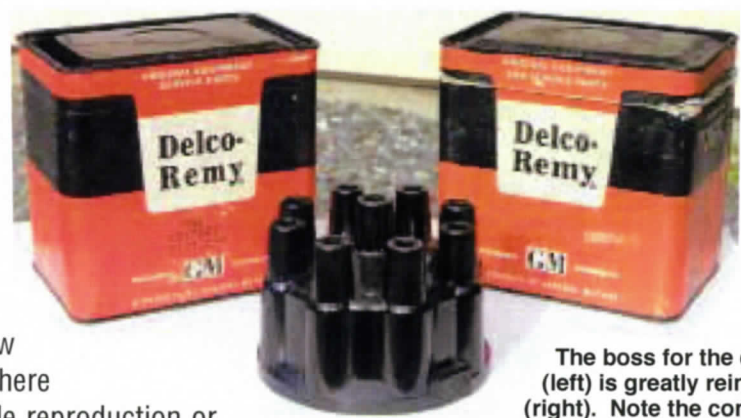
One surefire way to determine if your D-305 cap is original is to remove it from an original unopened box.

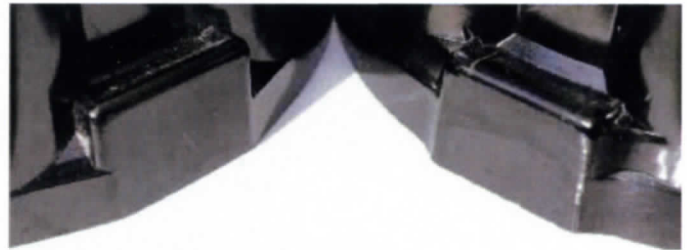
The boss for the clip on the original (left) is greatly reinforced on the replacement (right). Note the concave reinforcements on either side of the replacement in place of the triangular indentations on the original and also the addition of a flat 45° surface at the back of the replacement.

Some replacements are nothing more than something that fits and does the job. But the AC Delco service replacement not only looks close to the original at first glance, it also features some improvements that make it stronger. The bosses on either side of the cap for the two spring steel clips endure the most stress and are thus the most prone to cracking. The service replacement addresses this as shown in the photo. So, save your original and run the service replacement on your car when it's not being judged.

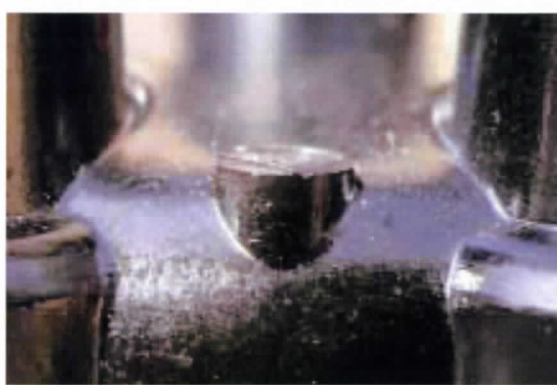
The casting mold marks are flat and off center to the right on the original (top photo), whereas they are quite tall on the replacement, which also has the mold mark more centered and over toward the edge (left).

Another difference involves the casting mold marks on the top of the cap that appear between each of the plug wire posts. On the original, they are flat, farther back from the edge of the cap, and offset to the right. On the service replacement, they are tall, on the edge of the cap, and nearly centered. Some reproduction caps have no casting marks on top at all, so these are immediately apparent as non-original.

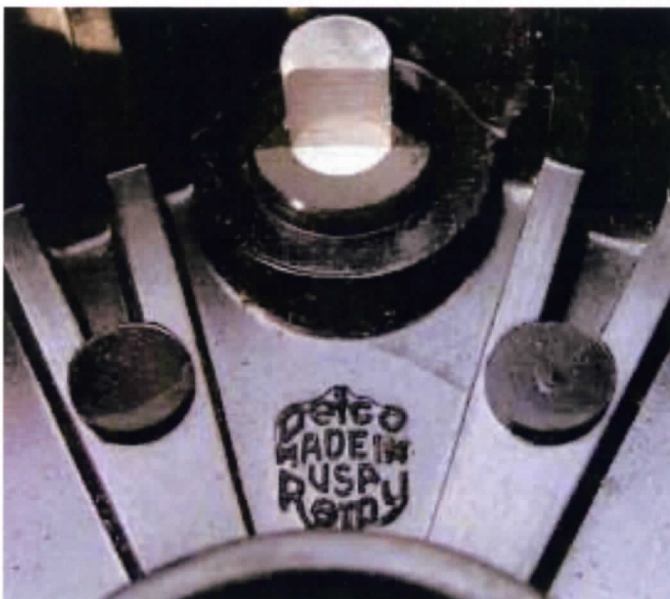
Delco-Remy logo inside an original D-305 cap

Lastly, all we need do to identify an original cap is to turn it over and look for the familiar Delco-Remy logo. This logo is absent from both the service replacement and reproductions.
