**Home Milling Exhaust Manifolds to Eliminate Gaskets**

Jim Kennedy, NCRS # 37463, Ubeg@comcast.net

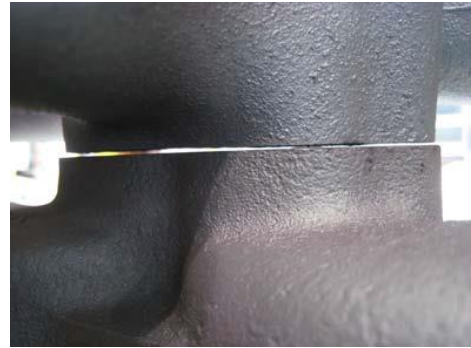
**Photo # 1**

When I recently had the chance to remove my exhaust manifolds (because of a broken valve guide and the need for a head rebuild), I figured that I would reinstall without the dreaded gaskets. That’s when I made an interesting (and apparently popular) discovery; the manifolds don’t seat perfectly to the heads machined casting. Knowing that the heads most likely were not the issue, I measured the manifolds and there it was – warpage! See Photo #1 which shows manifolds back to back – it’s hard to see but this measures several thousandths of an inch).

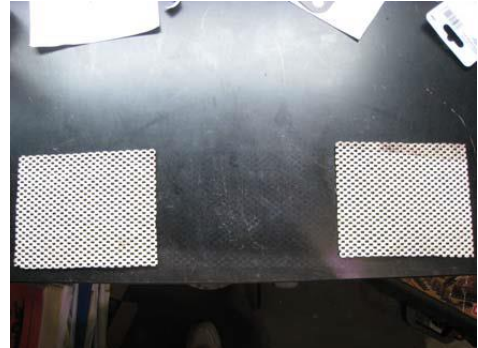
**Photo # 2**

Basically I took a 1” X 6” X 36” piece of marble with some rubber shelf liner to keep it “stuck” to the work bench (see Photo # 2).

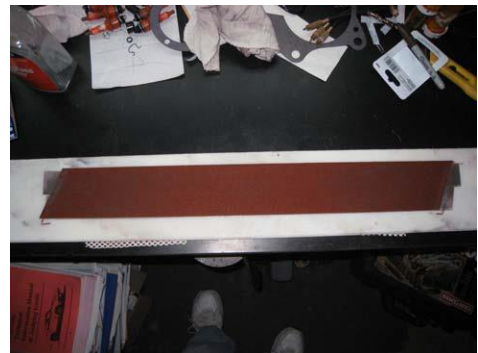
**Photo # 3**

Then using carpet tape (very thin double sided tape) and a cut open 3” X 24” sanding belt (80 grit) and stuck it to the marble (see Photo # 3).

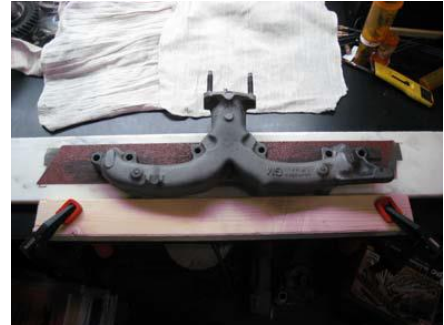
**Photo # 4**

Next I clamped a wooden stop to the edge of the bench and placed the rubber/marble/80 grit assembly against it and was ready to go (see photo # 4).

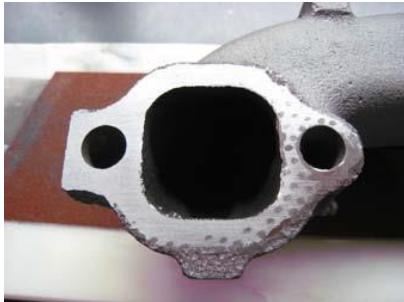
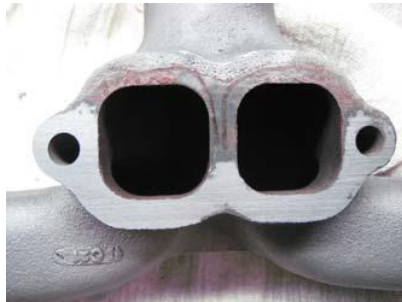
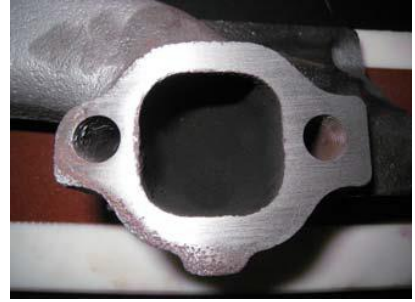
Slow back and forth motion with some downward pressure and a couple of hours later, I had machined manifolds ready for high temp coating treatment and bolt back on. (See Progress Photos # 5, # 6, # 7 below for views of ½ way there)

Now it did take a couple of hours each side because you can only do that back and forth motion for only so long AND the cast iron “dust” needed to be cleaned form the 80 grit – sometimes I used a shop vacuum and sometimes I just passed a magnet over the dirty belt and cleaned off the cast iron “dust”. But it worked, didn’t cost more than \$20 and I may pick up a couple of points on my next flight judging adventure.

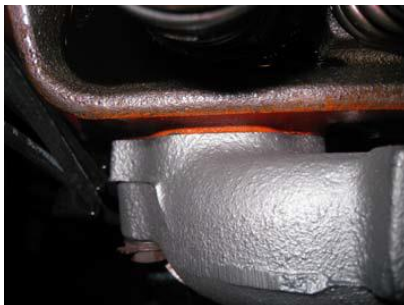
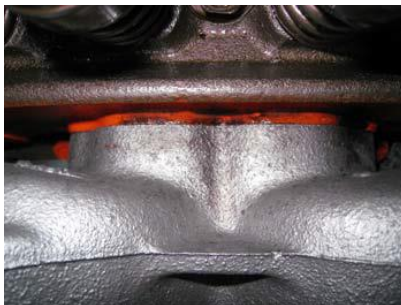
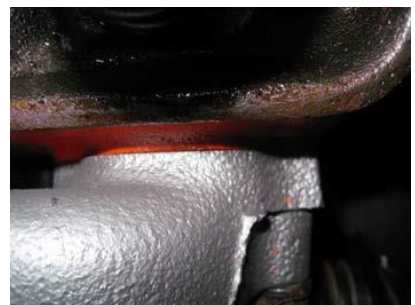
(See Photos # 8, # 9, # 10 below for finished installed connections)
