**Spring-Time Again:
An Examination of the 1963-1982 Heavy Duty Rear Spring
by
Gary Beaupre & Joe Lucia**

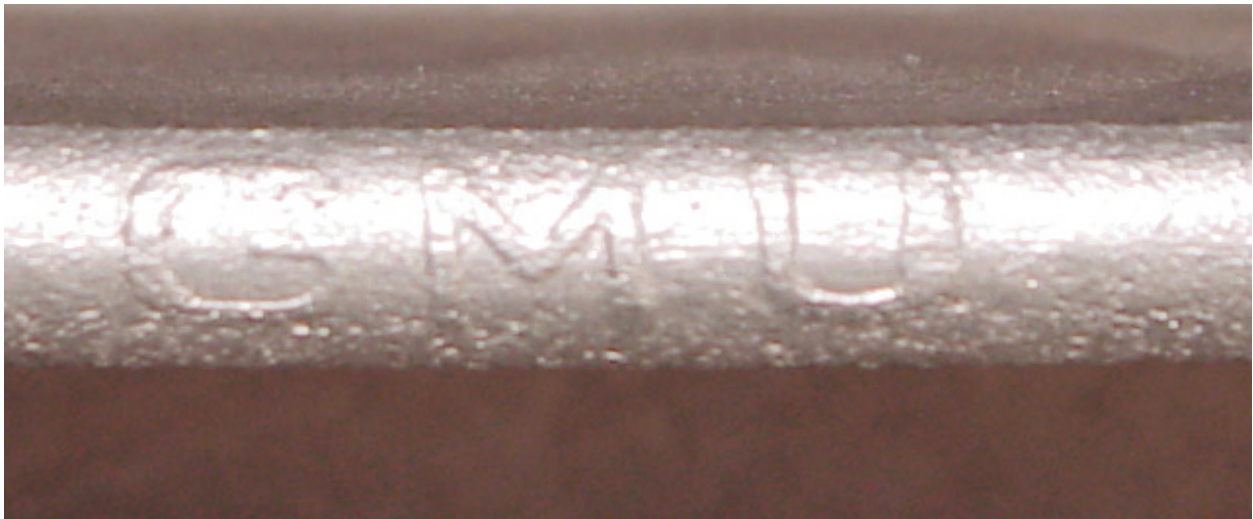
Fig. 1 Photo of "GMU" embossing on a 7-leaf, heavy duty spring (photo by Craig Schultz). This embossing has also been observed on 9-leaf, standard springs.

During the course of this research project we became aware of several other interesting spring-related items. One observation that was pointed out to us by several NCRS members is the presence of embossed (raised) letters on the edges of some spring leaves. The observed letters are either GMU or GM-U. Examples of these embossings are shown in Figs. 1 & 2. The GMU embossing shown in Fig. 1 has been observed on both standard and heavy duty springs.

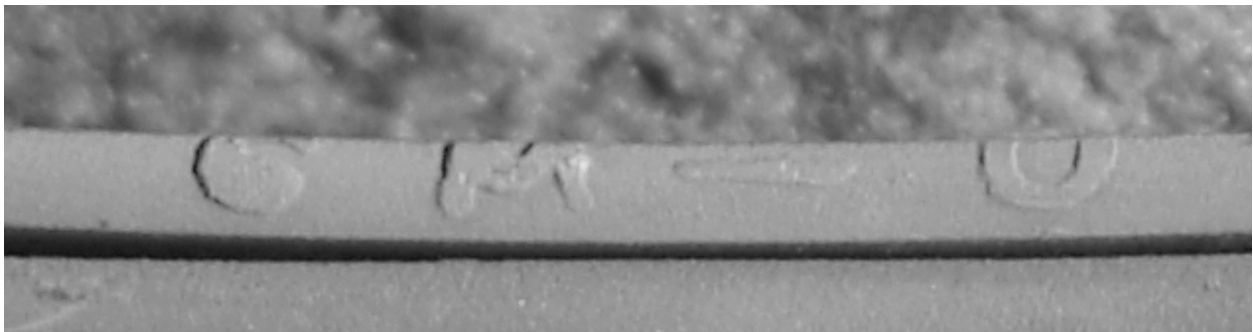
Fig. 2 Photo of "GM - U" embossing on a 9-leaf, standard spring (photo by Craig Schultz).

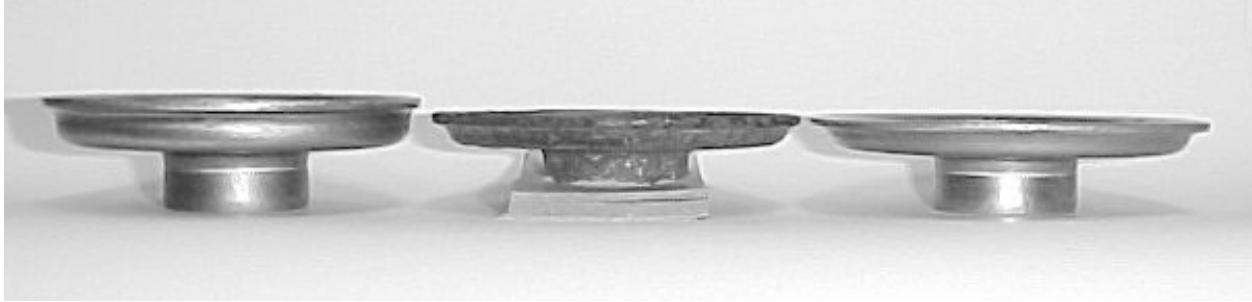
Fig. 3 Photo showing the currently available GM retainer (left), an original retainer (minus a portion of the bottom section that was destroyed during removal) from an original 1966 leaf spring, and the modified retainer (right) that more closely approximates the lip height and angle of the original mid-year retainers.

Another spring related item of particular interest to owners of mid-year cars is a change made by GM in the retainers that insert into holes in each end of the spring main leaf. These retainers serve to constrain a large rubber bushing. During the 1963-1967 model years, these retainers were GM part # 3831588. This part was discontinued from service in 1967 and superseded by part 3910701, which remains available today. The earlier part number was used on all mid-year cars, while the later part number was used from 1968-1982. People restoring the leaf spring (or the trailing arms, which also use 2 identical retainers) for 63-67 cars have to choose between restoring original 3831588 retainers or buying new 3910701 retainers. Unfortunately, these retainers are made from steel, that was neither plated nor painted. As would be expected, original 3831588 retainers are often rusty and pitted, making restoration difficult. Typically, restorers opt for using the 3910701 retainers. The 3831588 and 3910701 retainers are, however, noticeably different in terms of the geometry of the peripheral lip that constrains the rubber bushing. On the currently available 3910701 part, the peripheral lip is 0.325" tall and oriented at approximately 80 degrees from the base plane. On the earlier 3831588 part, the lip is noticeably shorter and is oriented at approximately 45 degrees from the base plane. This difference in lip height and angle is easily detectable by a knowledgeable and observant chassis judge and can lead to a points deduction during judging. However, it is possible to modify the 3910701 retainer to mimic the 3831588 retainer. In Fig. 3 we show the 3910701 retainer on the left, an original (badly rusted) retainer at the center and a modified retainer on the right.

The modified retainer shown in Figs. 3 and 4 gives 63-67 restorers a third option in addition to the previous ones of trying to restore an old and typically damaged part or using a new, but obviously incorrect part.

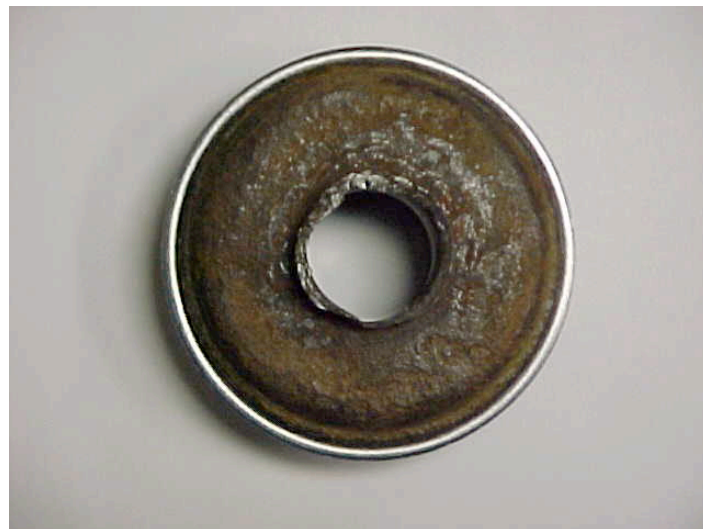
Fig. 4 Top view looking down onto a rusty original retainer placed face to face against a newly modified retainer showing a slight increase in the radius of the peripheral lip on the modified part.

Figure 4 is a top view looking down on the original retainer that has been placed face-to-face against a modified retainer. The effects of the modification process can be seen as a slight increase (approximately 85 thousandths of an inch, or slightly less than the thickness of two dimes stacked together) in the outer radius of the peripheral lip.
