Replacing Retainer Cups in a C2/C3 Rear Leaf Spring

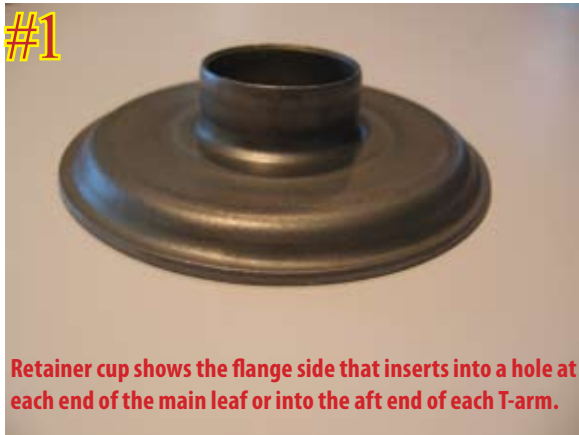
Restoring a rear leaf spring on a C2 and C3 can both improve the cosmetics of the rear suspension and restore ride height. The easy tasks in such a restoration are replacing the center bolt, repainting the spring leaves and replacing the inter-leaf polyethylene liners. However, it's more of a challenge to replace the retainer cups (Fig. 1) that are swaged into each end of the main leaf.

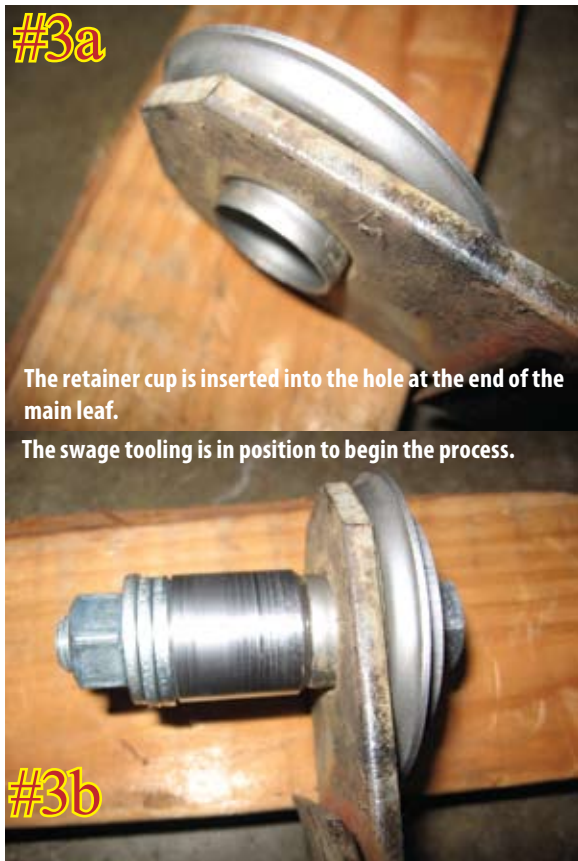
The following figures show a retainer cup inserted into the end hole in the main leaf of a rear leaf spring before and after placement of the swage tooling.

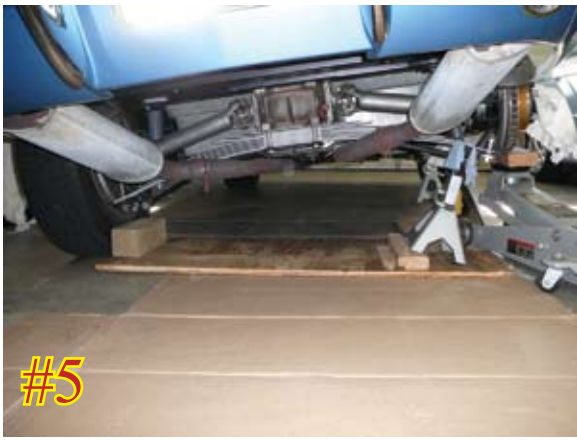
#5
Plywood and blocking system in position to allow removal and replacement of the retainer cups on the passenger's side. The sequence of steps leading up to the stage shown in this figure is explained in detail in the text.

The technique involves the use of a floor jack and three jack stands to support and stabilize the car and the various rear suspension parts. The other essential items include: 1) a piece of 5/8"-thick plywood approximately 2' x 5,' 2) a twelve-inch piece of 4"x 4" fence post stock, 3) a twelve-inch long piece of 2"x 4" wall stud, and 4) one or two twelve-inch long 1"x 2" wood cleats. These wooden pieces are assembled as is shown in Fig 5.

In brief, the 4 x 4 piece is securely attached via nails, screws, or bolts to

one end of the plywood. This piece serves as blocking and will be positioned against the inboard surface of the rear tire on the opposite side of the retainer cups to be replaced. The piece of 2 x 4 is attached via nails/screws/bolts to the plywood along with the cleats at a location approximately three feet from the first 2 x 4 block.

Next, position the plywood with attached blocking as shown in Fig. 5. Then, place a jack stand (four-legged, not three) under the passenger's side end of the leaf spring with two legs of the jack stand on top of the 2 x 4 with the legs pushed up snug against the 1 x 2 cleat and the other two jack stand legs on the plywood. (See Fig. 6) This 2 x 4 block and cleats must be

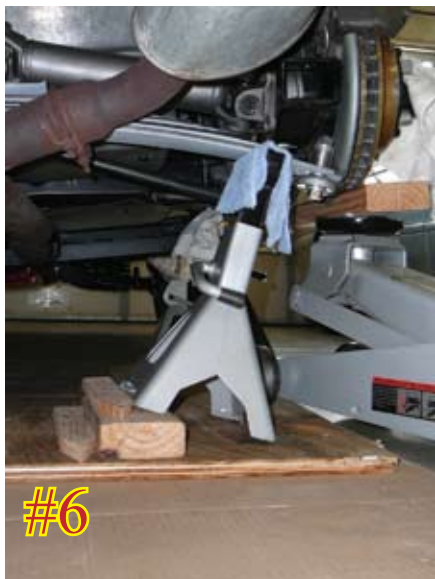
#6
Close-up photo showing the position of the jack stand under the end of the leaf spring. Note that the vertical axis of the jack stand is close to perpendicular to the arch of the spring. This photo shows the stage of the process after removal of the link bolt, with the new retainer cup in place and with the swaging tooling in place ready to perform the swaging step.

The top of the jack stand should be 2" to 3" inboard of the leaf spring retainer cup. The purpose of the 2 x 4 block is to angle the jack stand so that the force between the jack stand and the spring is close to perpendicular to the local tangent to the arch of the spring. The purpose of the cleat screwed to the top of the block is to prevent the jack stand from shifting in the direction of the driver's side. The second cleat secured to the plywood just to the left of the 2 x 4 block in Fig. 6 is for added security.

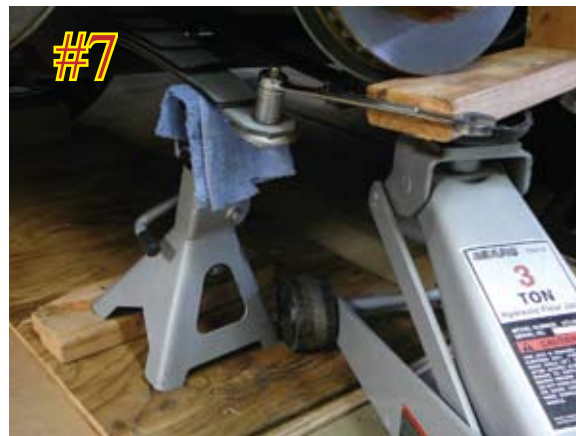
#7
Photo showing the swaging tooling in place to perform step one of the swaging process for the retainer cup at the end of the leaf spring. The entire swaging process of all four retainer cups can easily be done by one person in a few hours.

The swaging is performed in three steps. First, the steel swage with the smaller radius nose is used, followed by the steel swage with the larger radius nose, followed lastly by the flat steel swage. During each of the three steps the central bolt is tightened until no more deformation of the retainer flange is seen. Note that in **Fig. 7** the box wrench used to hold the upper nut of the swaging tooling is positioned against a 2 x 4 placed under the rotor. The forward end of the 2 x 4 (not shown) abuts against the kick-up area of the car's frame. This setup allows the swaging to be performed by one person. Most people will find that it takes two hands and a breaker bar (not shown) to tighten the swaging bolt during each of the three tightening steps of the swaging process.
