01.29.04

This is a task I was dreading. The headlight motor rebuild. I could send them off for \$128 per motor, or do it myself. I decided to do it myself after Gary C from Castle Rock...

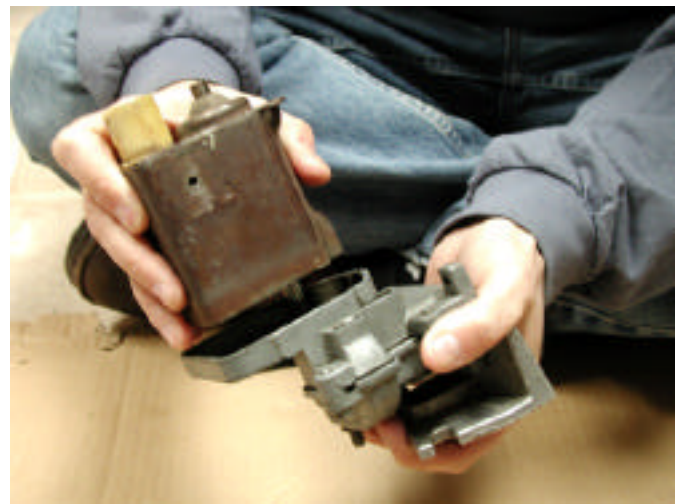
Pull the two sections apart. You may want to do this the opposite of how I show it here in case your "junk" wants to fall out. In my case it didn't, but it could have I suppose.

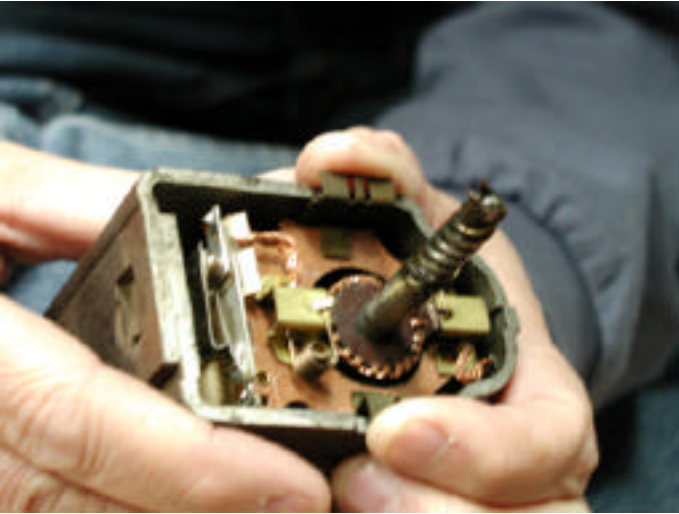
Remove the brush assembly by pressing up on the retaining clips as shown. Remember the one against the curved side is soldered to the housing.

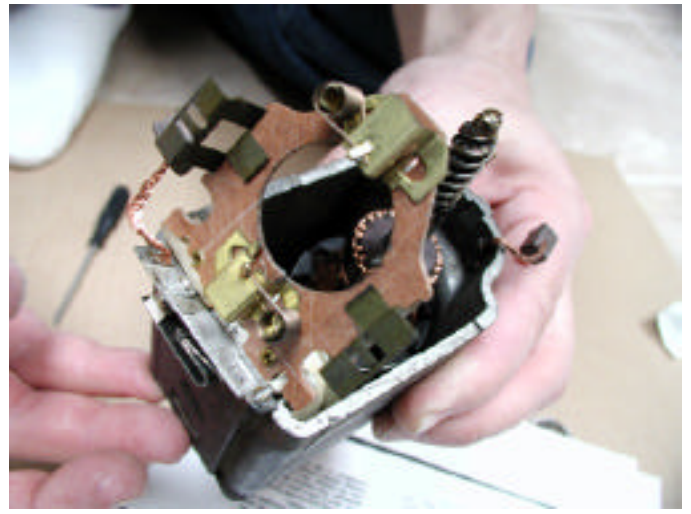
Do not fear the jack in the box brushes, they will spring out of their casing, but will stay attached via copper wire.

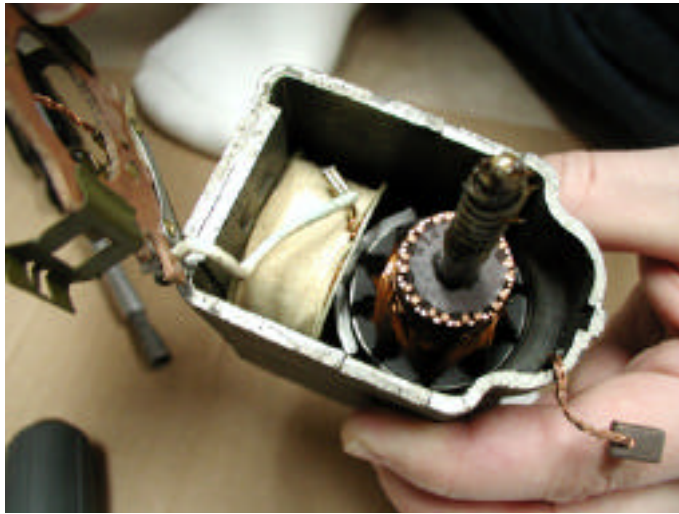
Once the brush assembly is out of the way you can remove the motor for inspection. If it is hesitant to come out DO NOT FORCE IT. Sand the end of the spindle that protrudes from the bottom of the casing (see arrow in next pic)

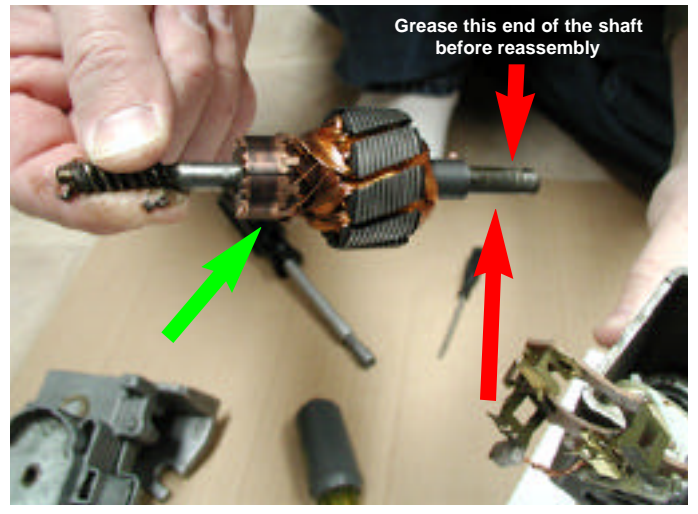
The reason for sanding the spindle is that corrosion may cause it to pull out the bearing in the bottom of the housing. And it is really hard to get it back in if it comes out. Notice the corrosion on the copper contacts (grn arrow)

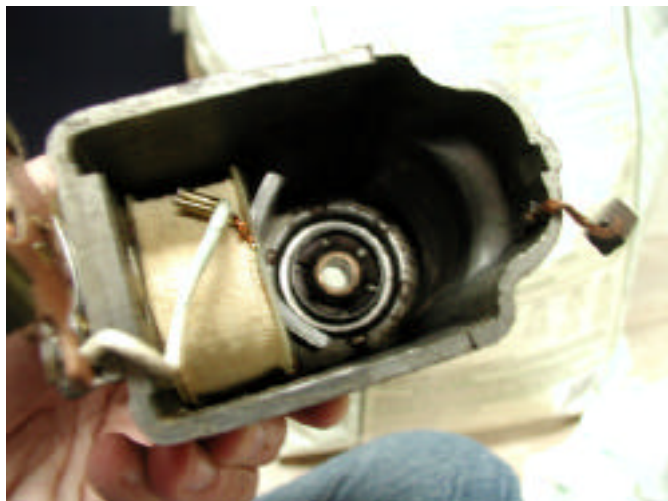
Here is what is left inside the housing. If the part shown here is bad, you can start crying aloud. Nobody will think any less of you. GM no longer makes this part.

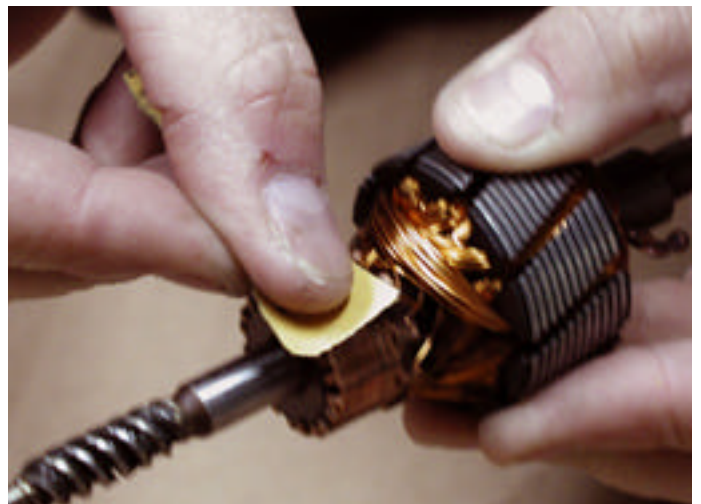
With really fine sand paper (I used 2000 grit) sand away any tarnish or corrosion on the contact area of the motor.

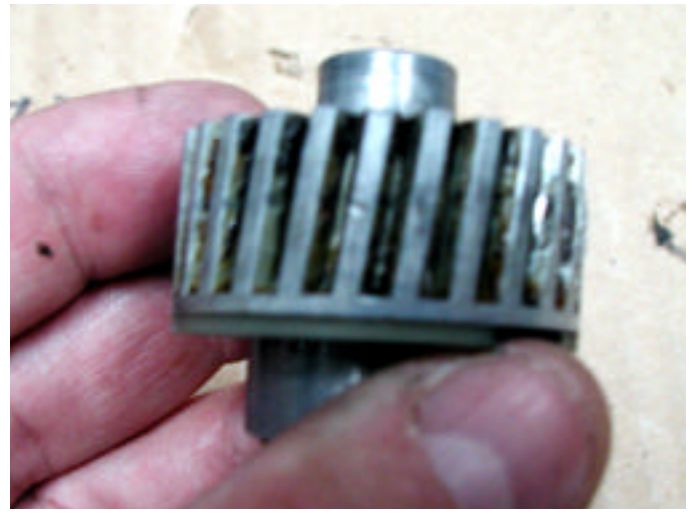
While the opposite side of the same pot metal gear is like brand spanking new. This is because the headlight movement from open to close only utilizes half of the gear's teeth.

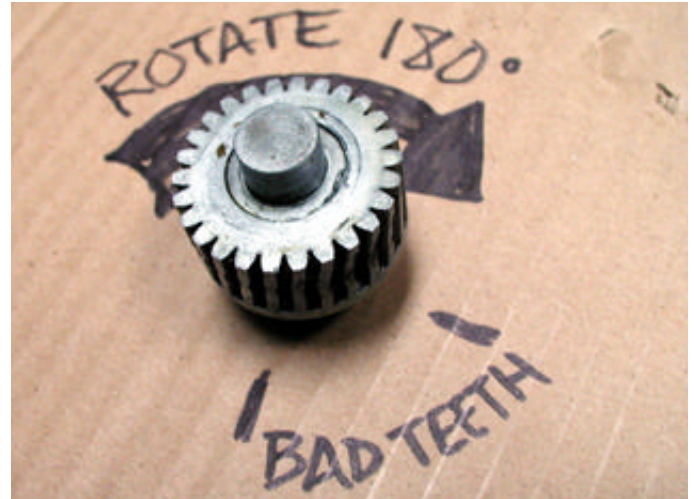
At first I thought I was supposed to "flip" the gear 180° which I soon found was not possible due to its construction. What you have to do, is rotate it in a circular fashion to put the bad teeth away from the worm gear.

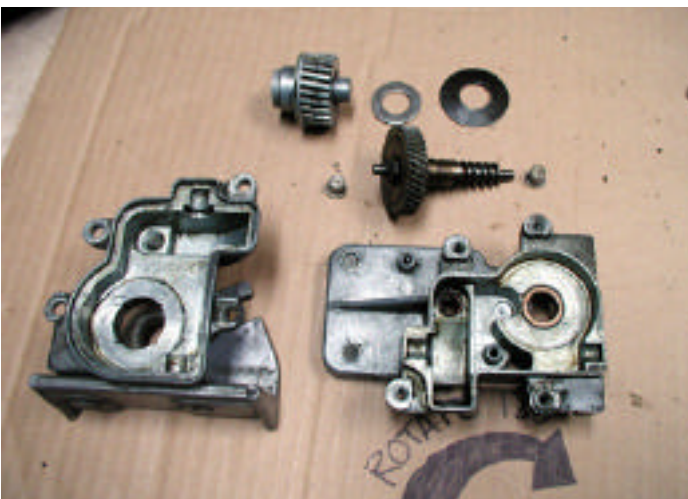
Notice my really clean parts and housing. You will do well to clean your stuff this thoroughly! After all cleanliness is next to godliness you know.

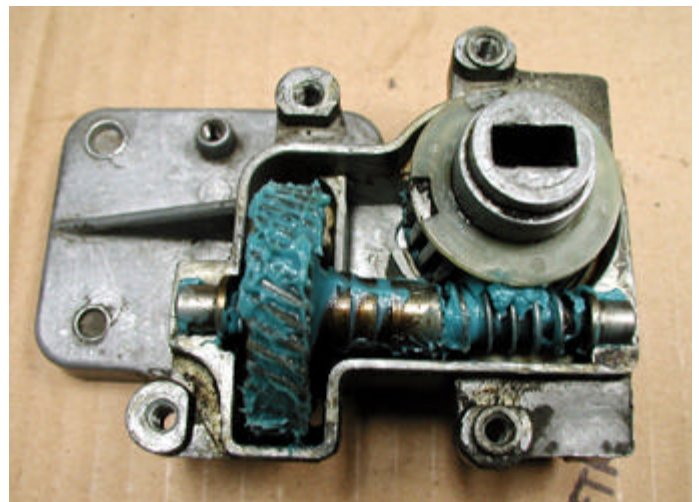
Grease it all, toss it back into the clam shell, seal it up. Mount it back to the motor portion (which you have already reassembled) and take it out to the car for a "test drive."

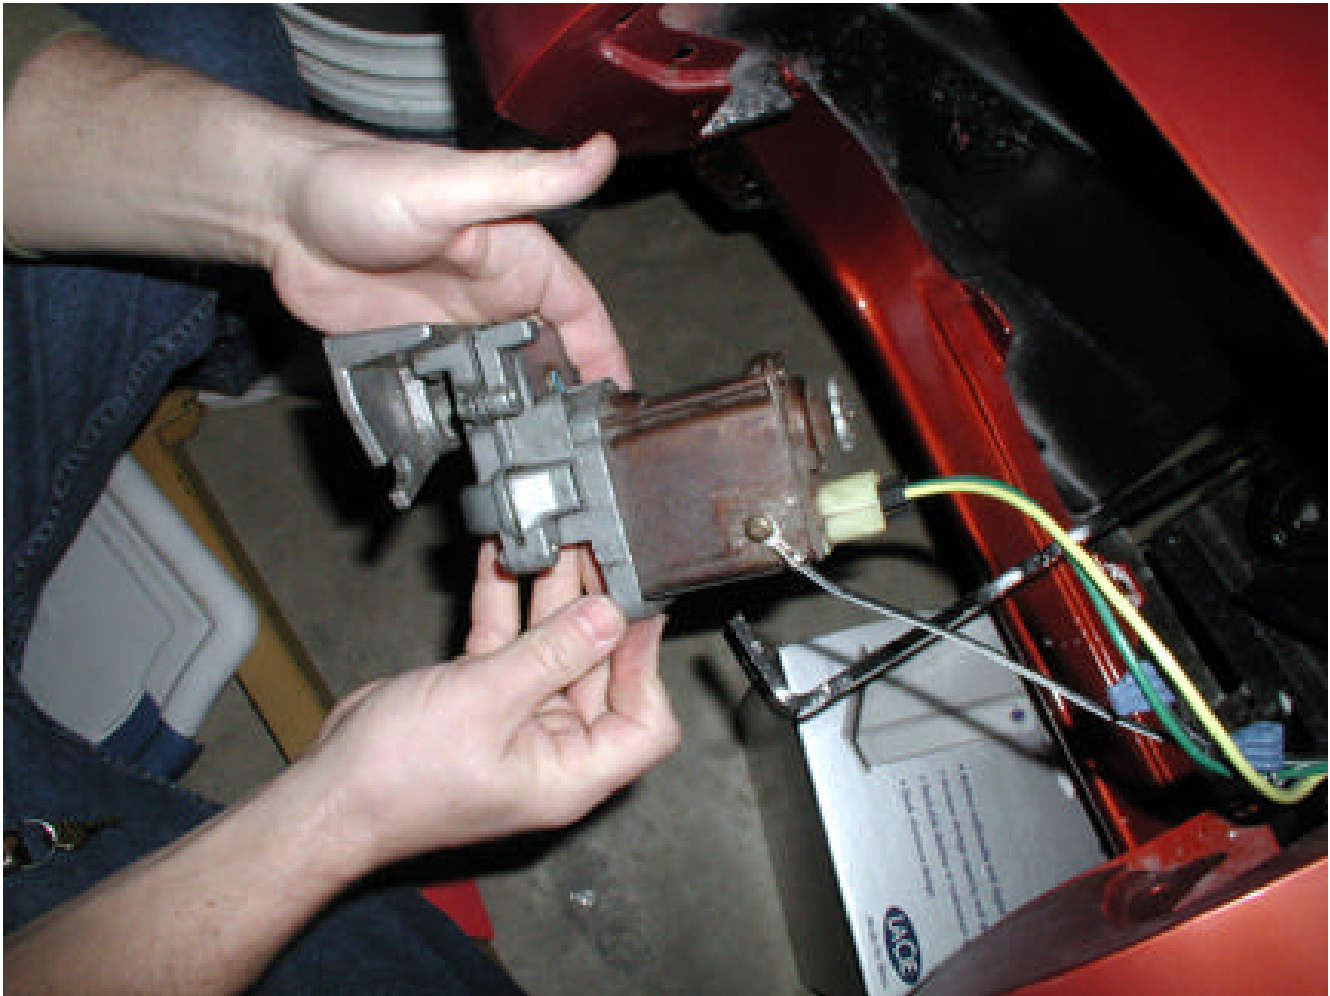
We took them out to the car and hooked them into the wiring harness for a quick test. They worked perfectly. One of the motors needed to be taken apart once again so that we could grease the bottom portion of the motor spindle where it passes through the bearing, but other than that it was far too easy to do.
